**UPPER TUOLUMNE RIVER BASIN
FISH MIGRATION BARRIERS STUDY
PROGRESS REPORT**

**LA GRANGE HYDROELECTRIC PROJECT
FERC NO. 14581**

Prepared by:
HDR, Inc.

February 2016

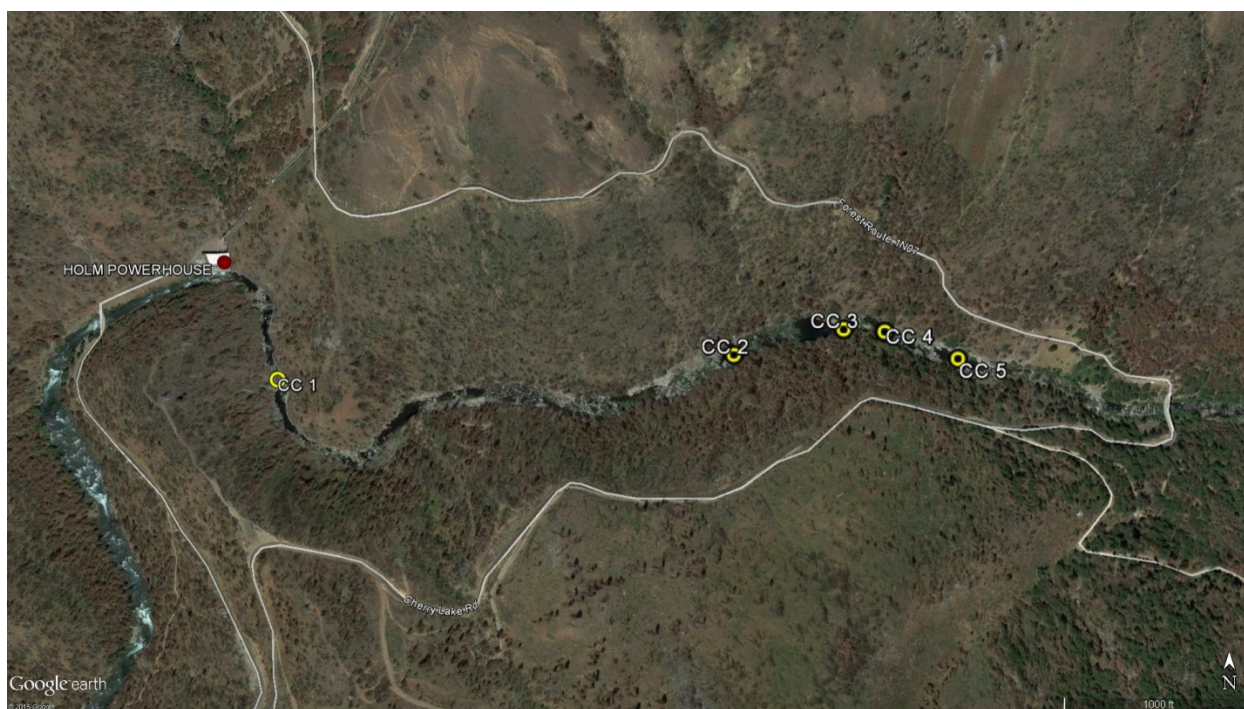
Figure 5.1-2. Features within two miles of Holm Powerhouse which may require field verification to determine barrier classification.

No information was found in the literature regarding fish passage barriers in Cherry Creek. A brief assessment of aerial photography using Google Earth imagery was performed to identify features which may require further field survey. The results of the aerial photography assessment revealed up to seven features within two miles upstream of Holm Powerhouse which exhibited visual characteristics consistent with hydraulic drops, e.g., large bedrock areas void of trees, confined channels, and areas of turbulence where hydraulic plunges or jets may be present. An example of such a feature is presented in Figure 5.1-1. The seven features identified through aerial photo review are provided in Figure 5.1-2.

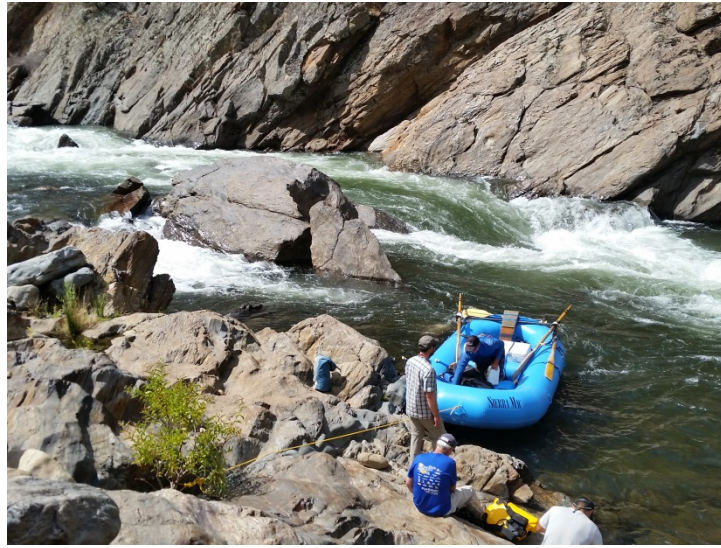
Photo 1

Description: Recreational flows, looking upstream at constriction step.

Barrier: Passable

Clavey Falls comprises a cascade sequence and several steps at RM 90 on the mainstem Tuolumne River. The downstream step is a constriction formed by a bedrock wall on river left and a large boulder (approximately 10 feet diameter) in the middle of the river (Attachment A, Photo 1). The main flow comprises a relatively smooth tongue on river left, with an approximately three-foot vertical drop. Both the launch and landing zones are deep and long (approximately 50 and 80 feet, respectively) with moderate velocity and turbulence. During observed on-peak flows, flow to the river right of the large boulder provides an alternative path, dropping approximately three vertical feet over a boulder-formed step. The launching pool has moderate depth and turbulence. The landing pool has moderate depth and low velocity. During observed flow conditions as low as 400 cfs, this pathway became too shallow to facilitate fish passage.

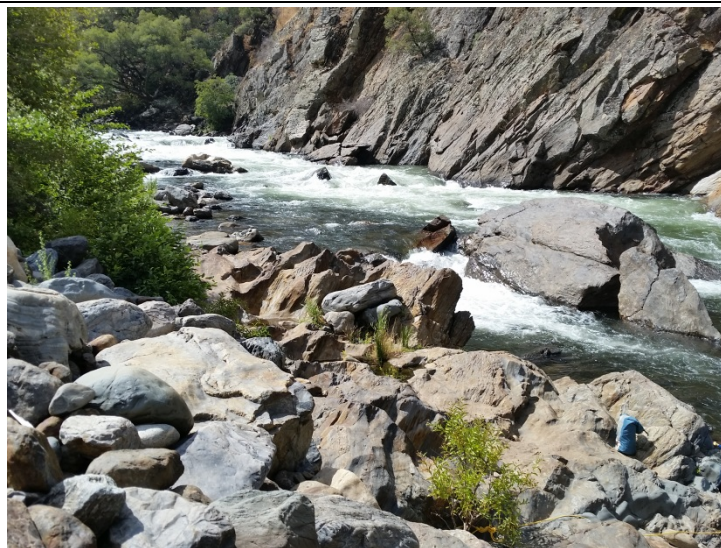
Photo 2

Description: Recreational flows, looking upstream at boulder steps.

Barrier: Passable

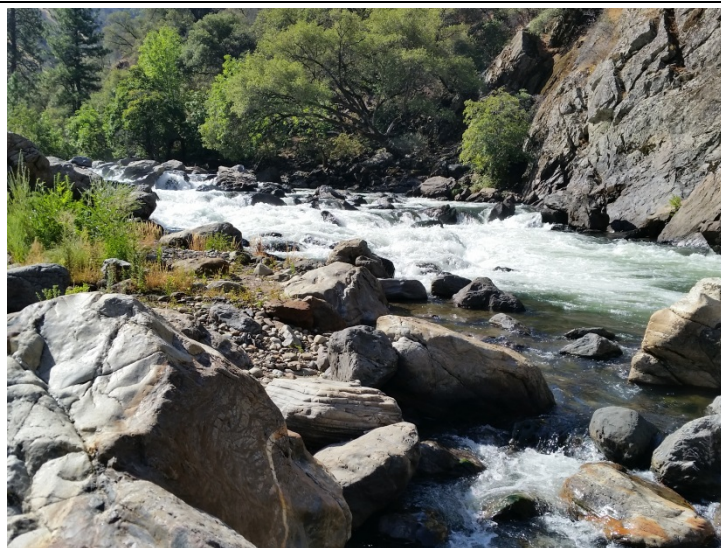
Photo 3

Further upstream, the cascade sequence extends for approximately 70 feet, with an approximate vertical rise of 6 feet (Attachment A, Photos 3 through 5). The cascade sequence occurs within a series of boulders ranging from approximately two to five feet in diameter, with multiple drops and pathways; the flow has high turbulence through this area, particularly at higher (recreational) flows. Steps within the cascade range from approximately one to three feet in height, with high velocity, high turbulence, moderate depth launching and landing zones. During low flow conditions there is an alternate, lower gradient, moderate velocity and turbulence pathway on the river left, with one clear step (approximately one to two feet in height) with high turbulence and velocity launching and landing zones of moderate depths.

Information collected during the field survey suggests that this feature is passable at a wide range of flow conditions. The feature is likely a barrier at very low flows but generally exhibits conditions sufficient for passage throughout the range of flows observed. This feature is classified as passable given that multiple pathways exist which exhibit unobstructed leap heights within the leaping capabilities for both spring-run Chinook and steelhead calculated in Section 4.3.

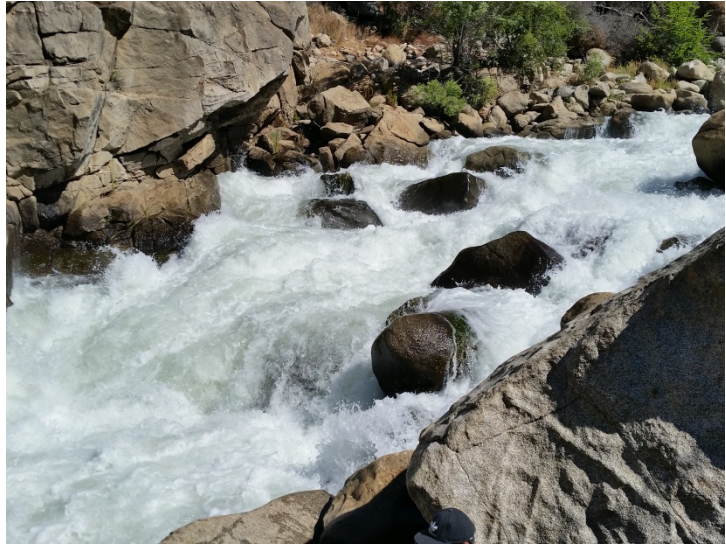
<p>Photo 10 Waterbody: Mainstem Tuolumne River Feature: Lumsden Falls River Mile: 97.3 Date: 8/5/2015 Time: 10:25 Image Name: IMG_20150805_102537_1451836945.jpg Coordinates: 37.84842667, -120.02952527 Total Vertical Height: 18 feet Description: Low flows, looking upstream from mid-falls. Barrier: Potential</p>

Lumsden Falls is a cascade feature located at RM 97.3 on the mainstem Tuolumne River (Attachment A, Photos 6 through 12). The flow takes multiple paths through a high gradient series of boulders confined by bedrock on river right. Boulders range in diameter from approximately 5 to 10 feet. During the August field survey, the flow had high turbulence throughout the length of the cascade at both recreational (1,200 and 950 cfs) and lower flow conditions (600 cfs). The main drop of the cascade is approximately 18 vertical feet over a distance of approximately 100 feet (18 percent gradient). A large, deep pool occurs at the bottom of the falls but has moderate turbulence, particularly at the presumed launching zone at

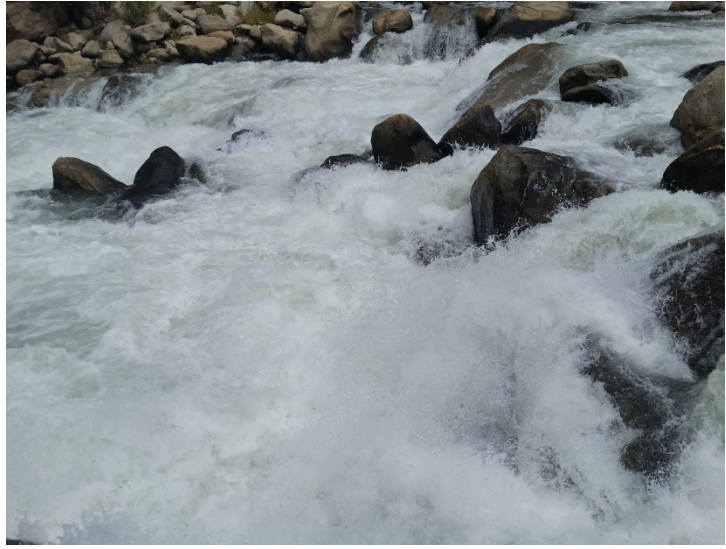
<p>Photo 11 Waterbody: Mainstem Tuolumne River Feature: Lumsden Falls River Mile: 97.3 Date: 8/6/2015 Time: 11:46 Image Name: IMG_20150806_114406_-428109626.jpg Coordinates: 37.84853852, -120.02931625 Total Vertical Height: 18 feet Description: Recreational flows, looking upstream from mid-falls. Barrier: Potential</p>

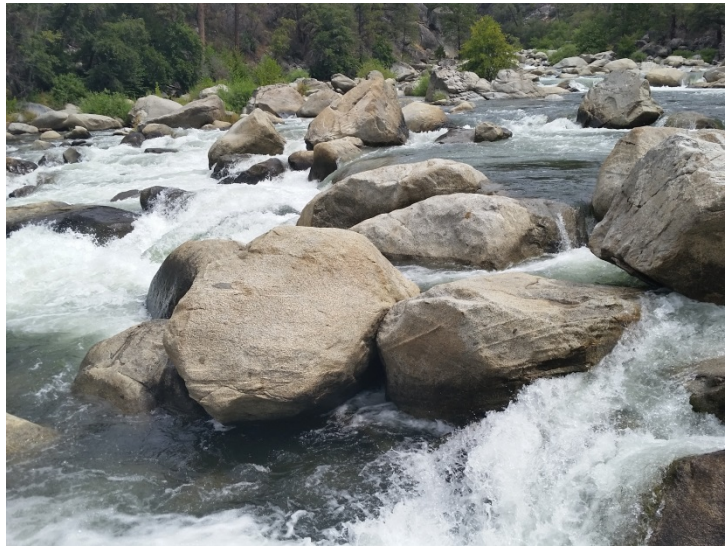
<p>Photo 12 Waterbody: Mainstem Tuolumne River Feature: Lumsden Falls River Mile: 97.3 Date: 8/6/2015 Time: 11:47 Image Name: IMG_20150806_114742_2071543936.jpg Coordinates: 37.84843521, -120.02914996 Total Vertical Height: 18 feet Description: Recreational flows, looking upstream at falls crest. Barrier: Potential</p>

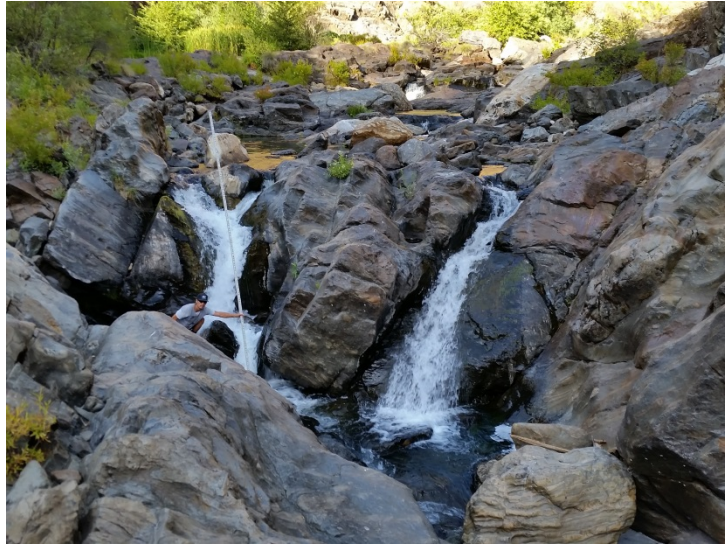
<p>Photo 13 Waterbody: Clavey River Feature: CR-1 River Mile: 0.2 Date: 8/3/2015 Time: 17:38 Image Name: IMG_20150803_173808_789570304.jpg Coordinates: 37.86620440, -120.11463213 Total Vertical Height: 12 feet Description: Looking upstream at split flow bedrock falls. Barrier: Partial</p>

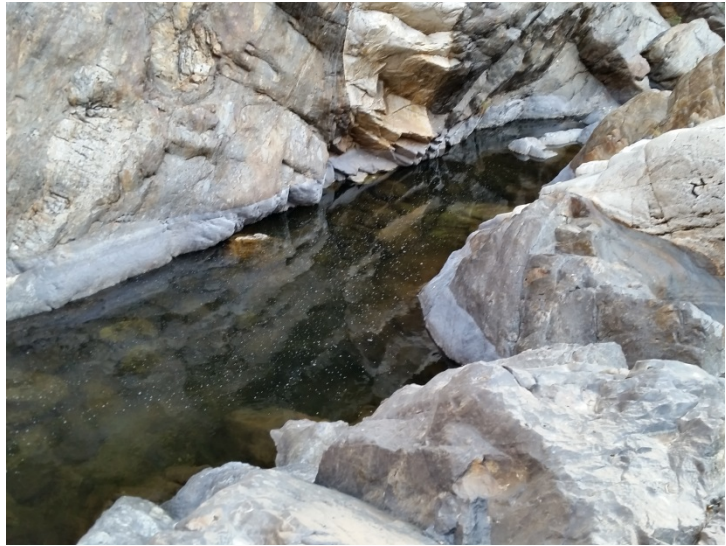
<p>Photo 14 Waterbody: Clavey River Feature: CR-1 River Mile: 0.2 Date: 8/3/2015 Time: 17:39 Image Name: IMG_20150803_173949_-865758468.jpg Coordinates: 37.86618723, -120.11466690 Total Vertical Height: 12 feet Description: Looking downstream at tail water control pool. Barrier: Partial</p>

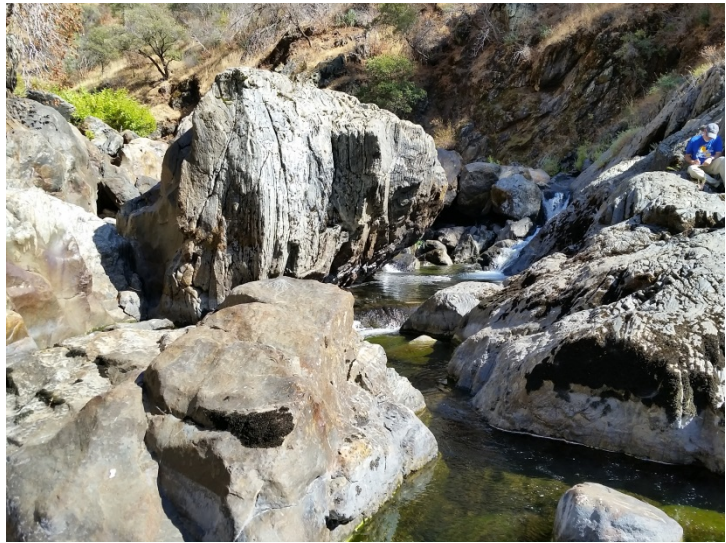
<p>Photo 15 Waterbody: Clavey River Feature: CR-2 River Mile: 1.15 Date: 8/3/2015 Time: 16:24 Image Name: IMG_20150803_162424_502621589.jpg Coordinates: 37.86219766, -120.10301435 Total Vertical Height: 8 feet Description: Looking upstream at split flow feature. Barrier: Partial</p>

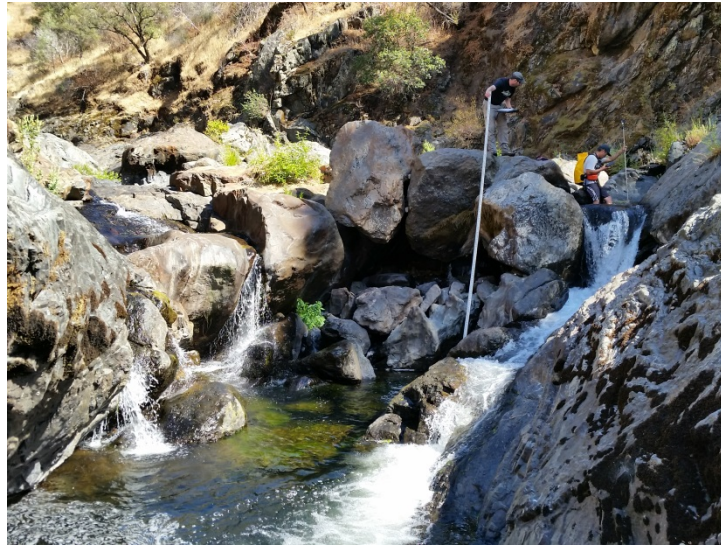
Photo 16

Description: Looking upstream at river left flow feature over bedrock chute.

Barrier: Partial

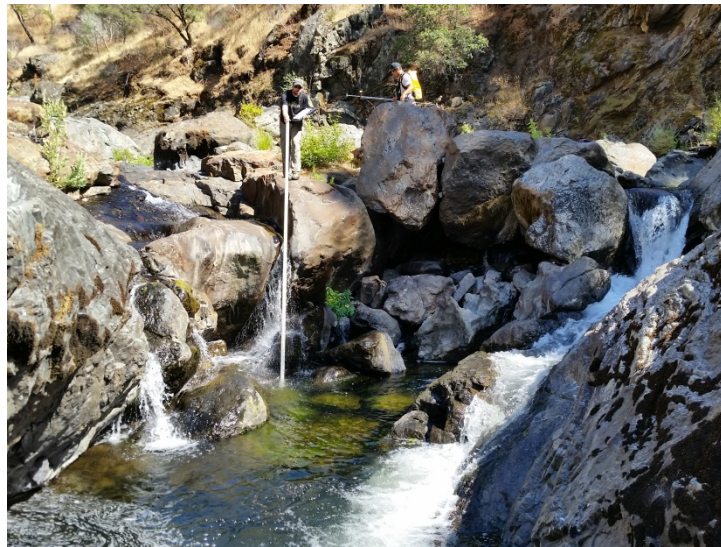
Photo 17

Description: Looking upstream at river right flow features over boulders.

Barrier: Partial

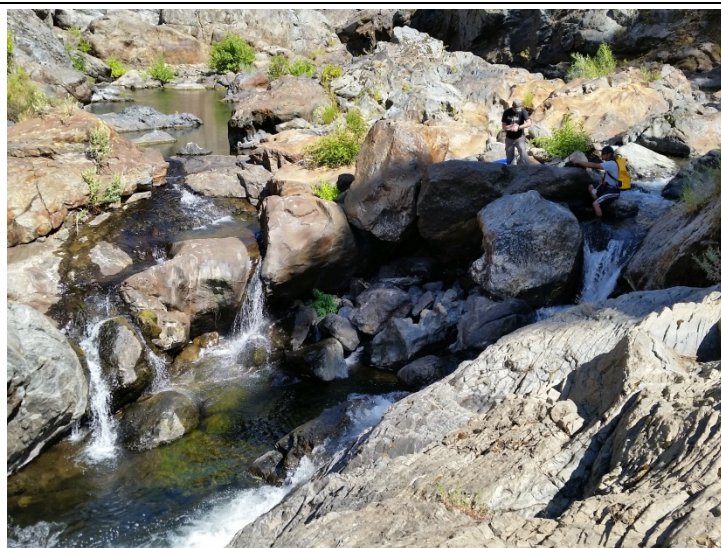
Photo 18

Description: Looking upstream at feature crest.

Barrier: Partial

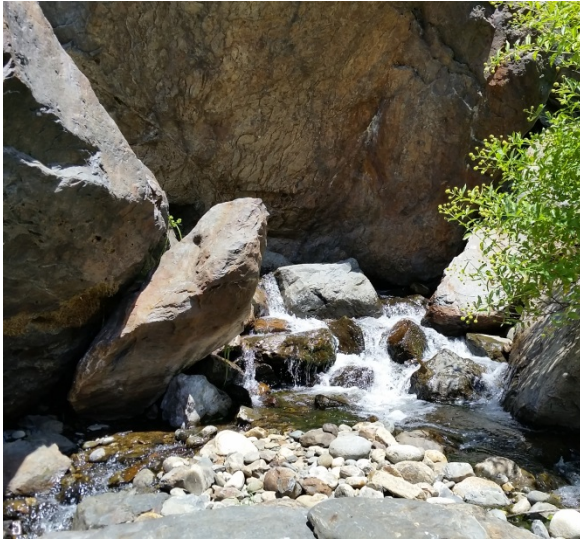
<p>Photo 20 Waterbody: Clavey River Feature: CR-3 River Mile: 2.05 Date: 8/3/2015 Time: 13:28 Image Name: IMG_20150803_132843_1574218901.jpg Coordinates: 37.86150460, -120.09135843 Total Vertical Height: not applicable Description: Looking upstream at flow under boulder with inadequate clearance for fish passage. Barrier: Total</p>

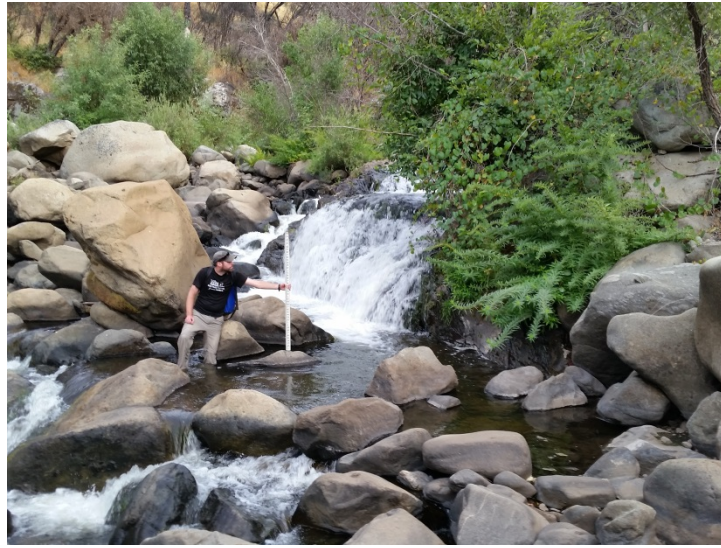
Photo 27

Description: Looking upstream at river right falls over bedrock.

Barrier: Partial

Feature ST-1 is a split flow falls over a bedrock outcrop located at RM 0.45 on the South Fork Tuolumne River (Attachment A, Photos 26 and 27). The flow is split roughly evenly, with river right flow down a continuously high velocity, high turbulence, high gradient chute, and river left flow down a bedrock-formed step-pool sequence. The total drop of the features is approximately five to seven vertical feet. The step-pool sequence contains two steps: a lower step that is at approximately three to five feet high, and an upper step that is approximately two feet high. The launching pool for the step is shallow with moderate turbulence but is unobstructed. The landing and launching pool in the middle of the step is set back somewhat from the drop and is shallow with moderate turbulence; the upper landing pool is also shallow, set back from the edge and has moderate turbulence and velocity. The two channels described represent the two alternative pathways present for fish passage.

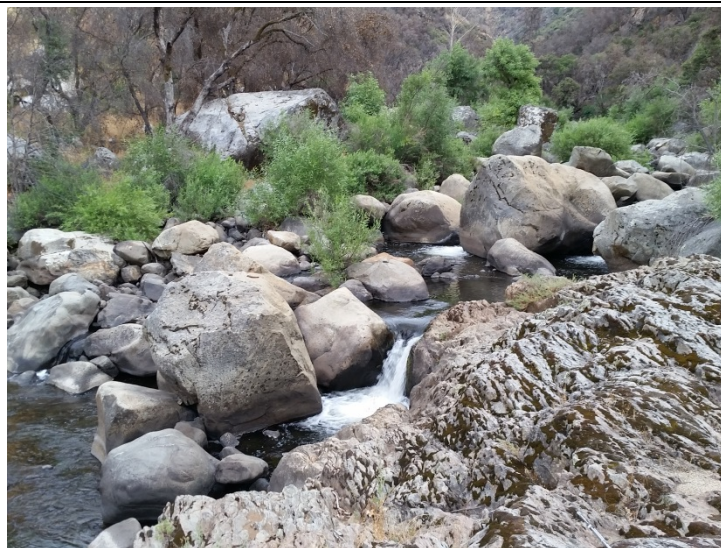
Photo 28

Description: Looking upstream at step pool falls.

Barrier: Partial

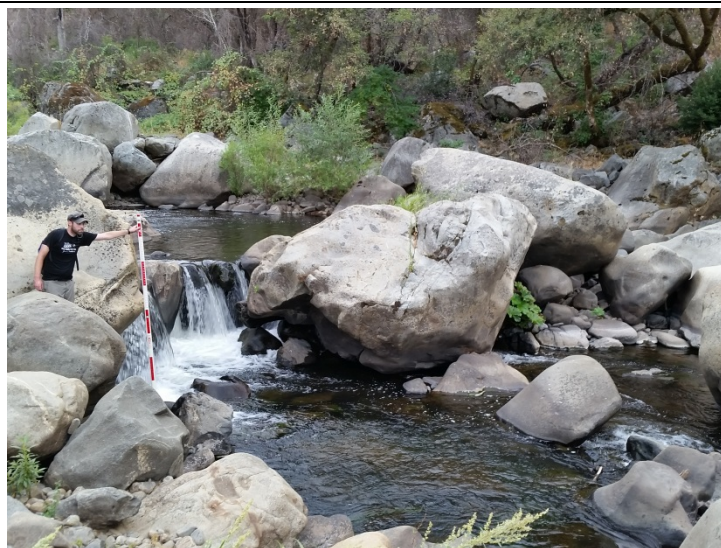
Photo 29

Barrier: Partial

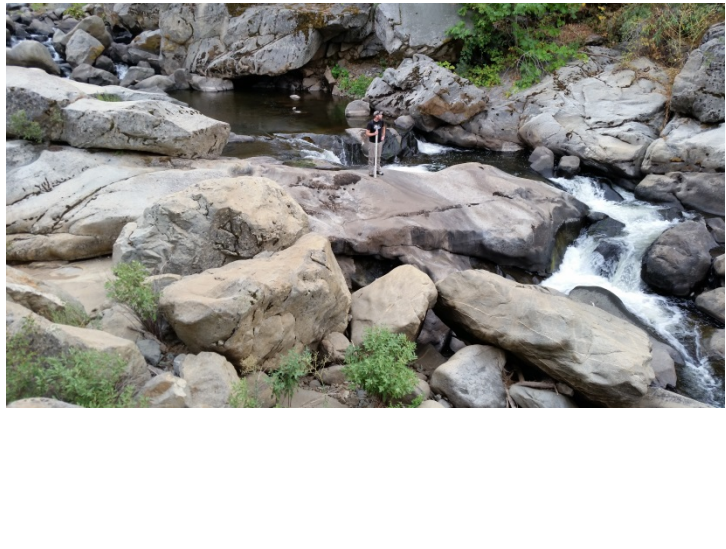
<p>Photo 32 Waterbody: South Fork Tuolumne River Feature: ST-6 River Mile: 0.95 Date: 8/5/2015 Time: 18:17 Image Name: IMG_20150805_181720_1605778994.jpg Coordinates: 37.82883430, -120.04079654 Total Vertical Height: 11 feet Description: Looking upstream at bedrock falls. Barrier: Partial</p>

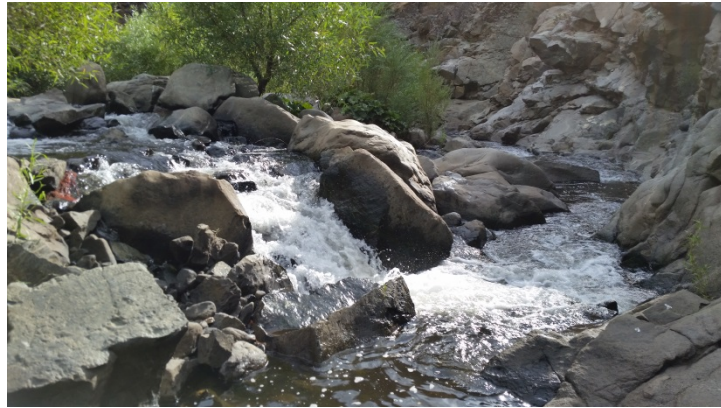
Photo 36

Description: Looking upstream at falls between boulders.

Barrier: Partial

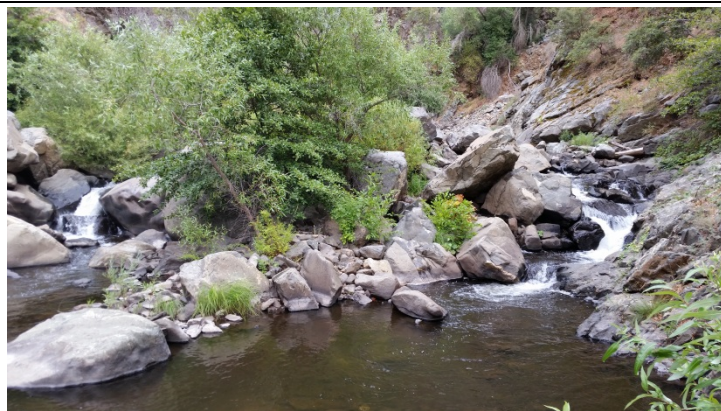
Photo 37

Description: Looking upstream at split flow step falls.

Barrier: Partial

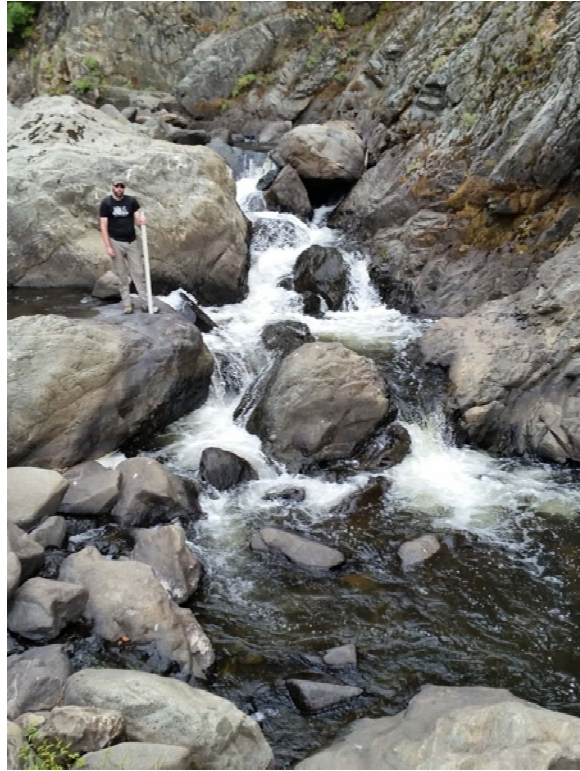
Photo 38

Description: Looking upstream at cascade.

Barrier: Partial

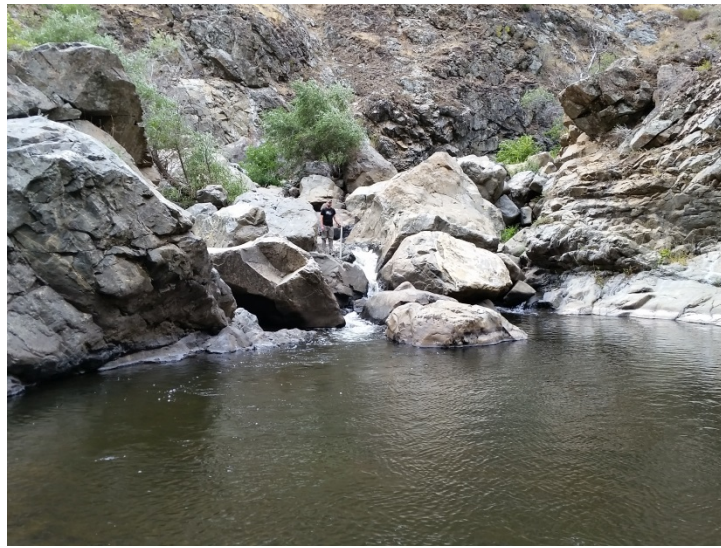
Photo 39

Description: Looking upstream at step pool falls.

Barrier: Partial

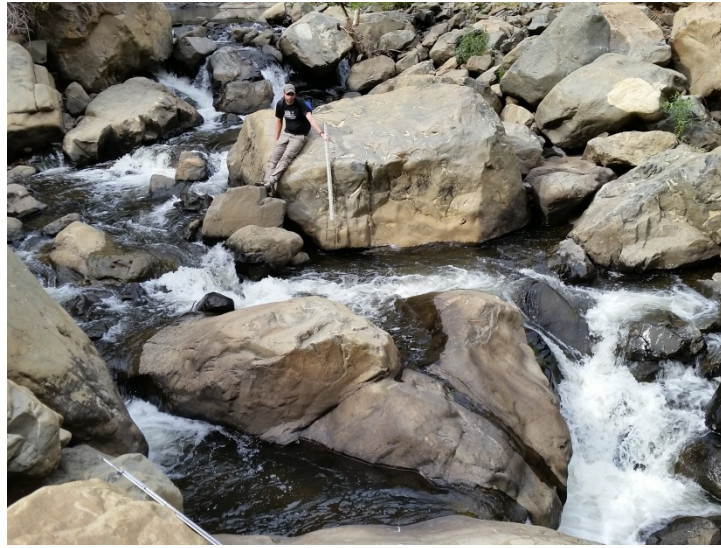
Photo 40

Description: Looking upstream at step pool falls.

Barrier: Partial

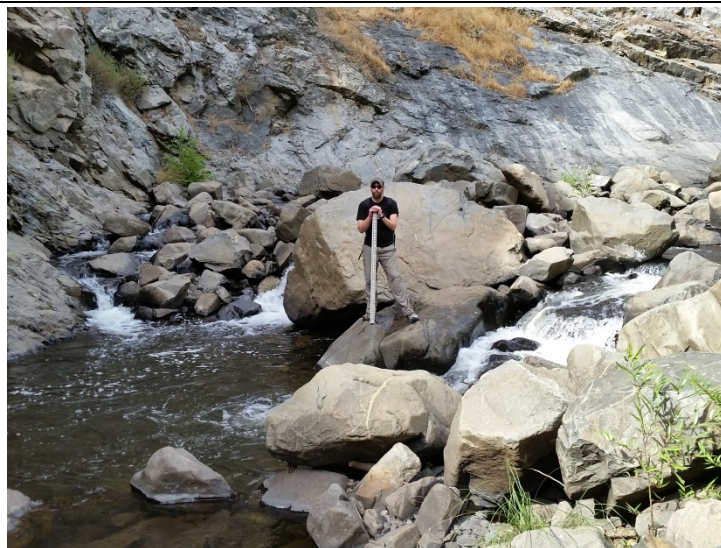
Photo 41

Description: Looking upstream at split flow step pool falls.

Barrier: Partial

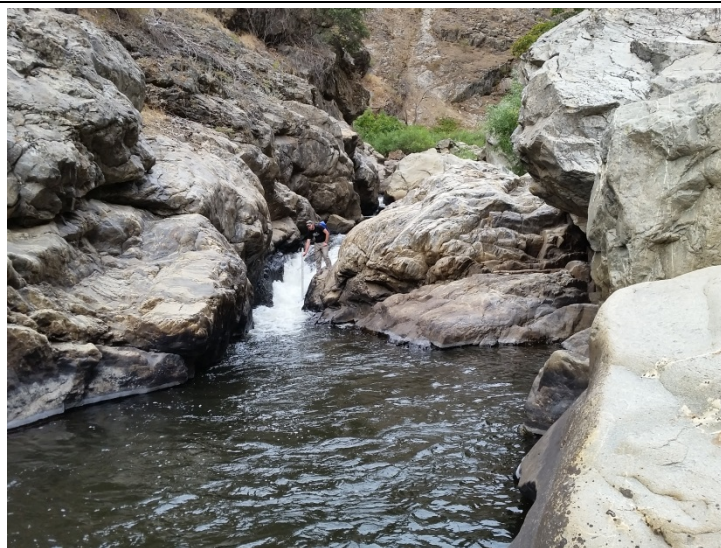
Photo 42

Description: Looking upstream at bedrock falls.

Barrier: Partial

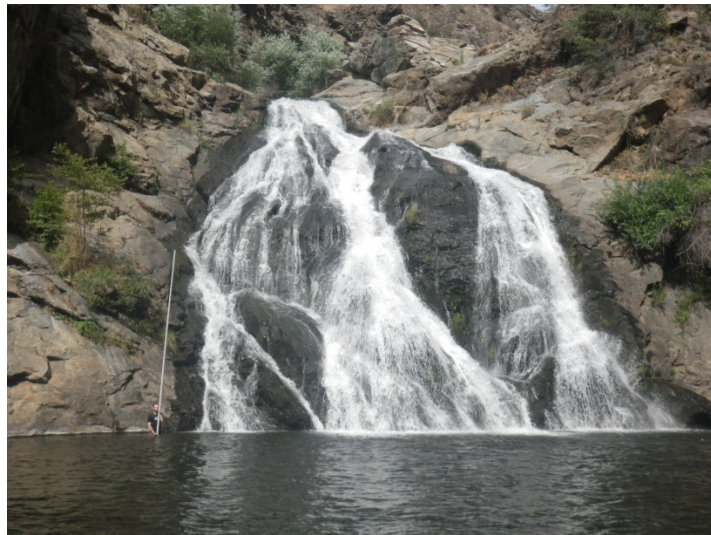
Photo 44

Feature ST-18 is a bedrock falls located at RM 1.9 on the South Fork Tuolumne River (Attachment A, Photo 44). The bedrock ledge extends the full width of the channel and river flows down the bedrock face. The falls have a total vertical drop of approximately 32 feet. Flow plunges into a deep, large pool (approximately 100 feet long). The bedrock canyon walls confines the river on both the river right and river left, therefore eliminating the development of alternative fish passage pathways.

Waterbody: South Fork Tuolumne River
