**LA GRANGE HYDROELECTRIC PROJECT
FERC NO. 14581**

UPDATED STUDY REPORT

APPENDIX J

**UPPER TUOLUMNE RIVER BASIN FISH MIGRATION BARRIERS
STUDY REPORT**

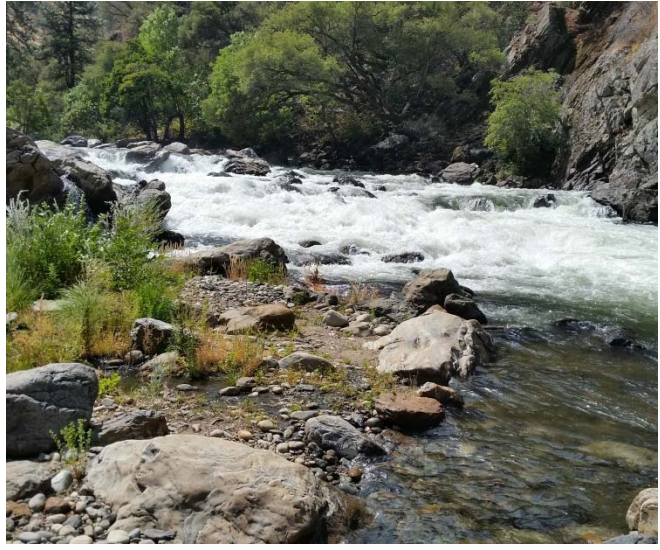
<p>Photo A-4 Waterbody: Mainstem Tuolumne River Feature: Clavey Falls River Mile: 90 Date: 8/4/2015 Time: 10:57 Image Name: IMG_20150804_105707_1230910478.jpg Coordinates: 37.86418216, -120.11777968 Total Vertical Height: 6 feet Description: Recreational flows, looking upstream at cascade. Barrier: Passable</p>

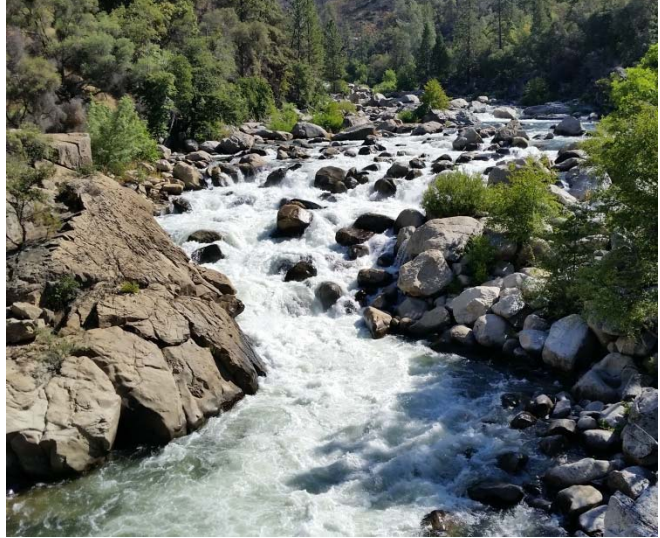
<p>Photo A-6 Waterbody: Mainstem Tuolumne River Feature: Lumsden Falls River Mile: 97.3 Date: 8/5/2015 Time: 09:59 Image Name: IMG_20150805_095948_1451836945.jpg Coordinates: 37.84819453, -120.02996637 Total Vertical Height: 18 feet Description: Low flows, overview looking upstream at cascade. Barrier: Potential</p>

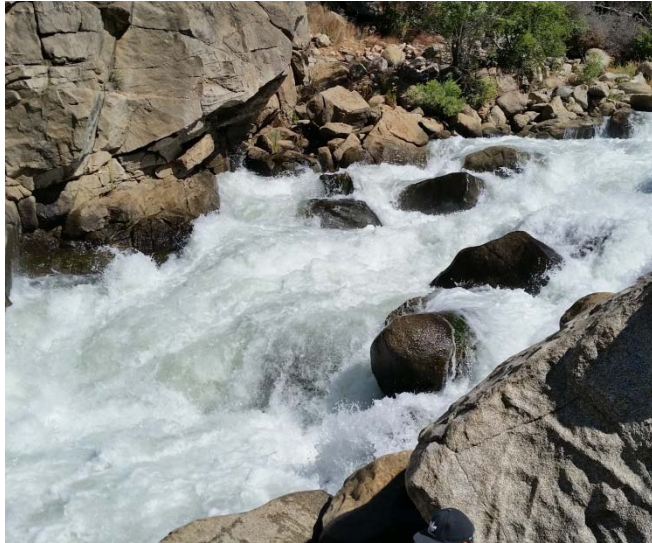
<p>Photo A-10 Waterbody: Mainstem Tuolumne River Feature: Lumsden Falls River Mile: 97.3 Date: 8/5/2015 Time: 10:25 Image Name: IMG_20150805_102537_1451836945.jpg Coordinates: 37.84842667, -120.02952527 Total Vertical Height: 18 feet Description: Low flows, looking upstream from mid-falls. Barrier: Potential</p>

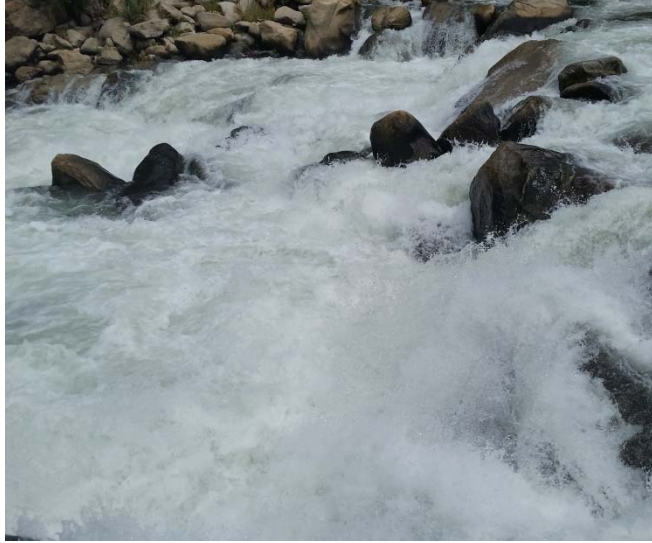
<p>Photo A-11 Waterbody: Mainstem Tuolumne River Feature: Lumsden Falls River Mile: 97.3 Date: 8/6/2015 Time: 11:46 Image Name: IMG_20150806_114406_-428109626.jpg Coordinates: 37.84853852, -120.02931625 Total Vertical Height: 18 feet Description: Recreational flows, looking upstream from mid-falls. Barrier: Potential</p>

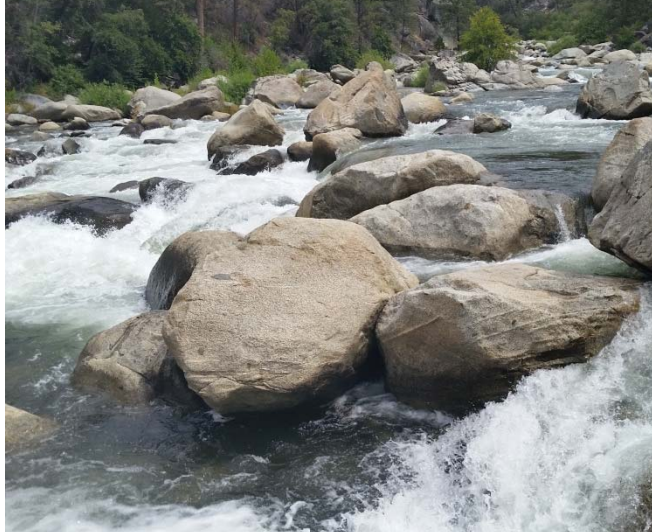
<p>Photo A-12 Waterbody: Mainstem Tuolumne River Feature: Lumsden Falls River Mile: 97.3 Date: 8/6/2015 Time: 11:47 Image Name: IMG_20150806_114742_2071543936.jpg Coordinates: 37.84843521, -120.02914996 Total Vertical Height: 18 feet Description: Recreational flows, looking upstream at falls crest. Barrier: Potential</p>

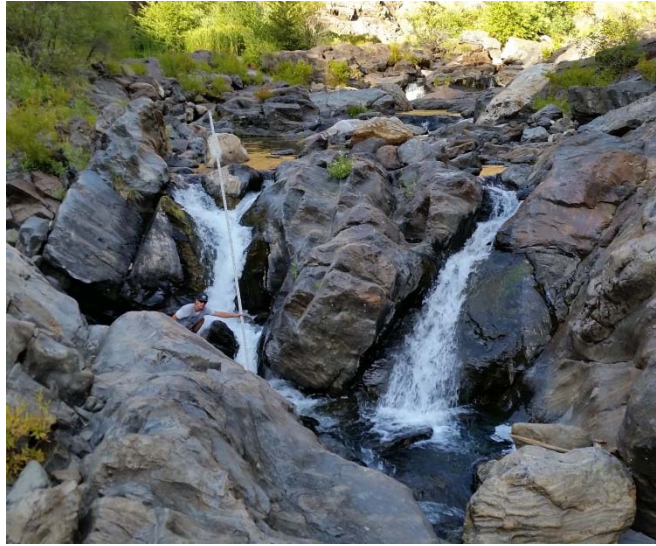
<p>Photo A-13 Waterbody: Clavey River Feature: CR-1 River Mile: 0.2 Date: 8/3/2015 Time: 17:38 Image Name: IMG_20150803_173808_789570304.jpg Coordinates: 37.86620440, -120.11463213 Total Vertical Height: 12 feet Description: Looking upstream at split flow bedrock falls. Barrier: Partial</p>

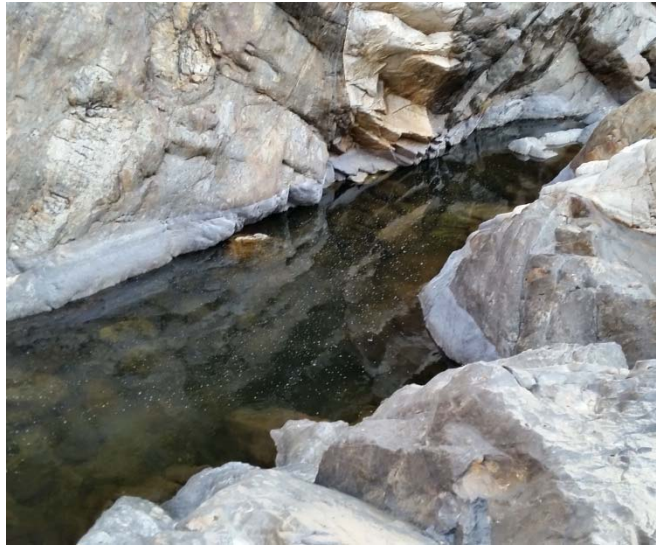
<p>Photo A-14 Waterbody: Clavey River Feature: CR-1 River Mile: 0.2 Date: 8/3/2015 Time: 17:39 Image Name: IMG_20150803_173949_-865758468.jpg Coordinates: 37.86618723, -120.11466690 Total Vertical Height: 12 feet Description: Looking downstream at tail water control pool. Barrier: Partial</p>

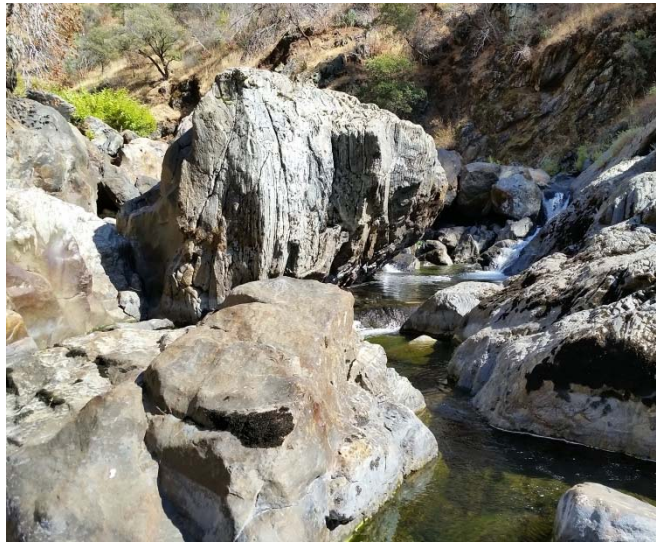
<p>Photo A-15 Waterbody: Clavey River Feature: CR-2 River Mile: 1.15 Date: 8/3/2015 Time: 16:24 Image Name: IMG_20150803_162424_502621589.jpg Coordinates: 37.86219766, -120.10301435 Total Vertical Height: 8 feet Description: Looking upstream at split flow feature. Barrier: Partial</p>

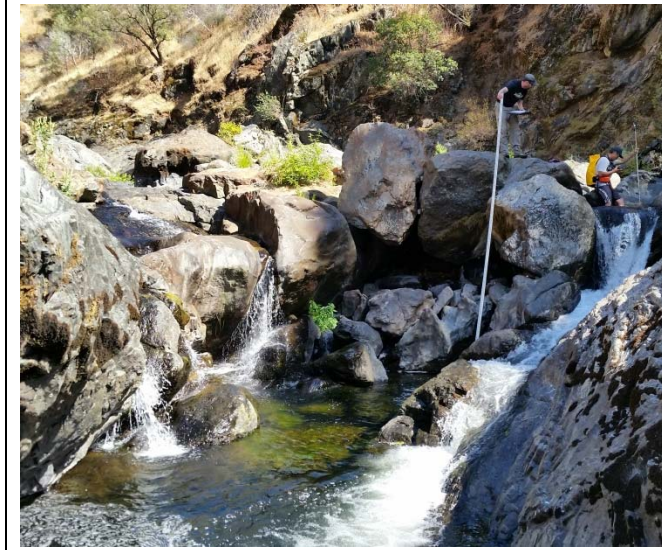
Photo A-16
Waterbody: Clavey River
Feature: CR-2
River Mile: 1.15
Date: 8/3/2015
Time: 16:05
Image Name:
 IMG_20150803_160556_1431754020.jpg
Coordinates:
 37.86201539, -120.10293057
Total Vertical Height: 8 feet
Description: Looking upstream at river left flow feature over bedrock chute.
Barrier: Partial

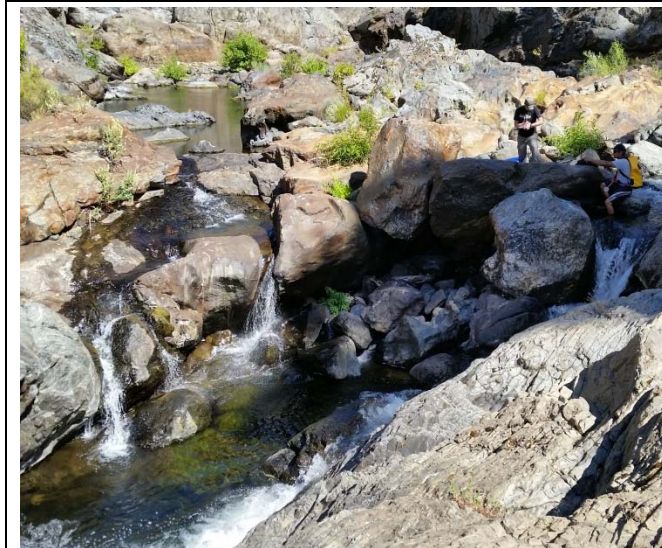
Photo A-18
Waterbody: Clavey River
Feature: CR-2
River Mile: 1.15
Date: 8/3/2015
Time: 16:00
Image Name:
 IMG_20150803_160000_1021997947.jpg
Coordinates:
 37.86205223, -120.10296322
Total Vertical Height: 8 feet
Description: Looking upstream at feature crest.
Barrier: Partial

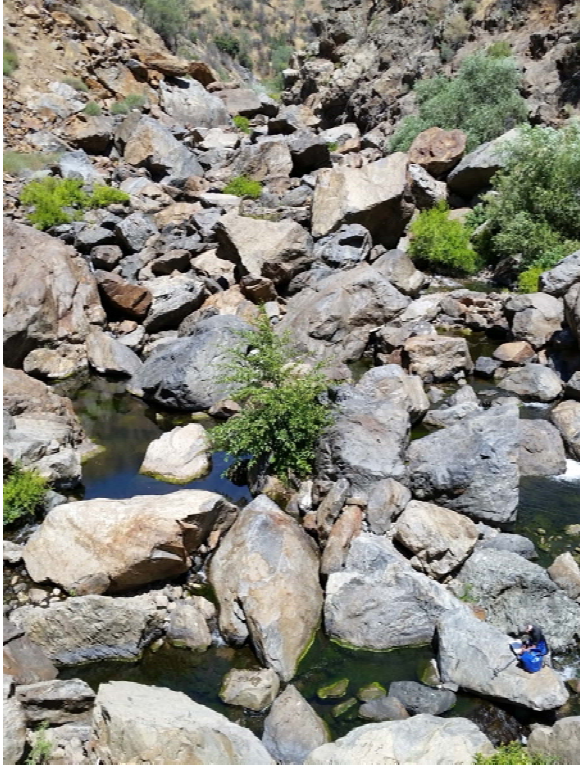
<p>Photo A-19 Waterbody: Clavey River Feature: CR-3 River Mile: 2.05 Date: 8/3/2015 Time: 13:40 Image Name: IMG_20150803_134054_1556097379.jpg Coordinates: 37.86087502, -120.09213326 Total Vertical Height: not applicable Description: Looking upstream at 400 feet long boulder field. Barrier: Total</p>

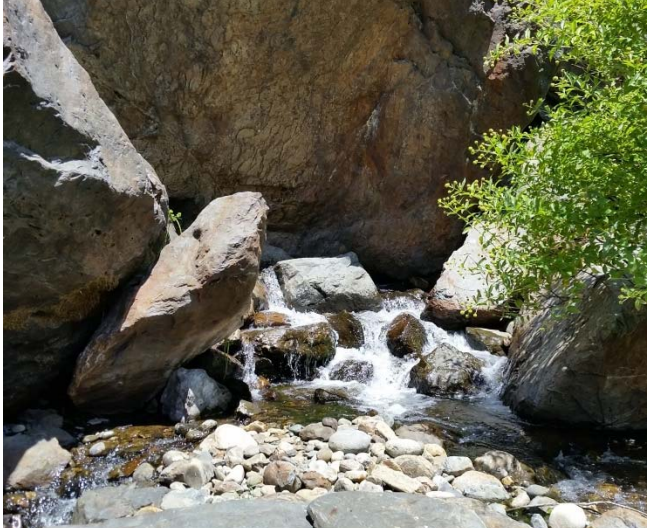
<p>Photo A-20 Waterbody: Clavey River Feature: CR-3 River Mile: 2.05 Date: 8/3/2015 Time: 13:28 Image Name: IMG_20150803_132843_1574218901.jpg Coordinates: 37.86150460, -120.09135843 Total Vertical Height: not applicable Description: Looking upstream at flow under boulder with inadequate clearance for fish passage. Barrier: Total</p>

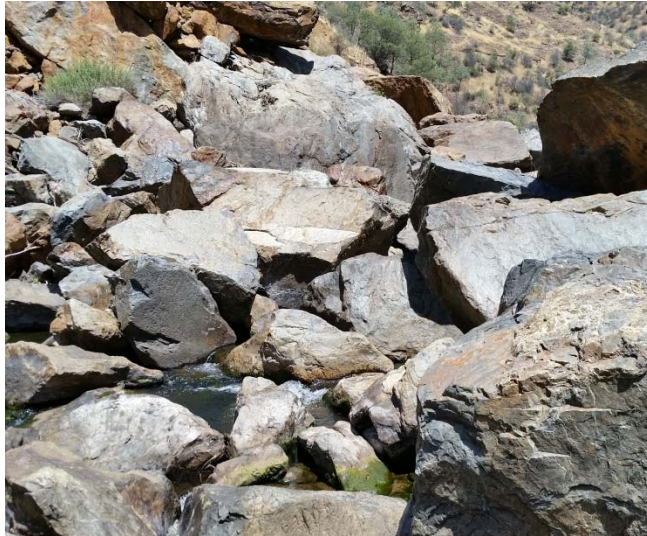
<p>Photo A-21 Waterbody: Clavey River Feature: CR-3 River Mile: 2.05 Date: 8/3/2015 Time: 13:15 Image Name: IMG_20150803_131516_139401152.jpg Coordinates: 37.86138223, -120.09151098 Total Vertical Height: not applicable Description: Looking upstream at flow through boulder field. Barrier: Total</p>

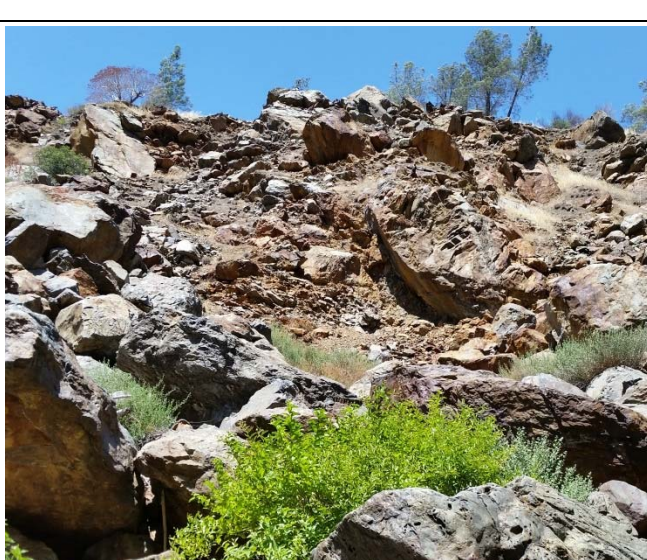
<p>Photo A-23 Waterbody: Clavey River Feature: CR-3 River Mile: 2.05 Date: 8/3/2015 Time: 12:54 Image Name: IMG_20150803_125441_1710042233.jpg Coordinates: 37.86157972, -120.09111681 Total Vertical Height: not applicable Description: Looking uphill at hill slope slide area feeding into boulder field. Barrier: Total</p>

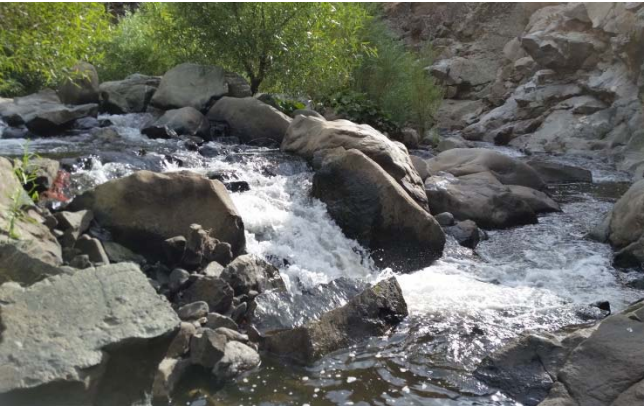
<p>Photo A-36 Waterbody: South Fork Tuolumne River Feature: ST-10 River Mile: 1.35 Date: 8/5/2015 Time: 17:37 Image Name: IMG_20150805_173718_2036909888.jpg Coordinates: 37.82671097, -120.03590602 Total Vertical Height: 3-5 feet Description: Looking upstream at falls between boulders. Barrier: Partial</p>

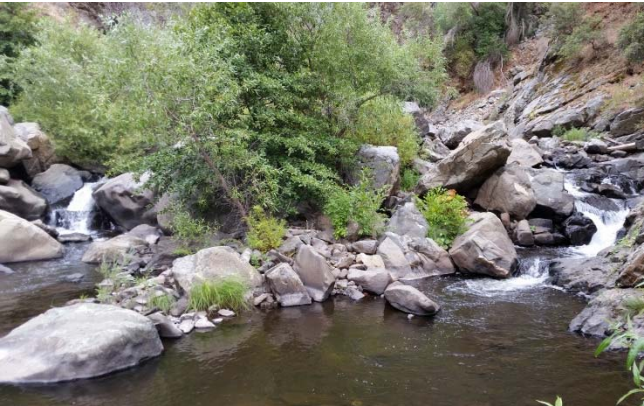
<p>Photo A-37 Waterbody: South Fork Tuolumne River Feature: ST-11 River Mile: 1.53 Date: 8/5/2015 Time: 17:15 Image Name: IMG_20150805_171534_1269685908.jpg Coordinates: 37.82512415, -120.03300482 Total Vertical Height: 3-5 feet Description: Looking upstream at split flow step falls. Barrier: Partial</p>

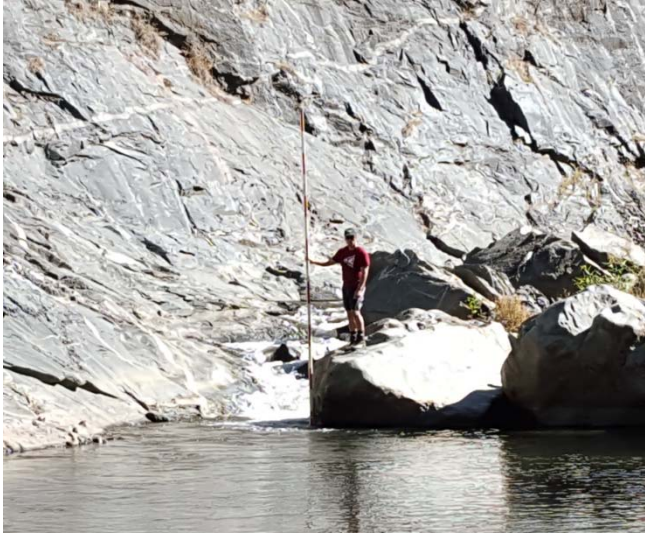
<p>Photo A-45 Waterbody: Cherry Creek Feature: CC-1 River Mile: 0.76 Date: 10/26/2015 Time: 12:59 Image Name: IMG_20151026_125924_1871653236.jpg Coordinates: 37.8962499, -119.9679786 Total Vertical Height: 5 feet Description: Looking upstream of Holm Powerhouse at bedrock step pool falls Barrier: Potential</p>

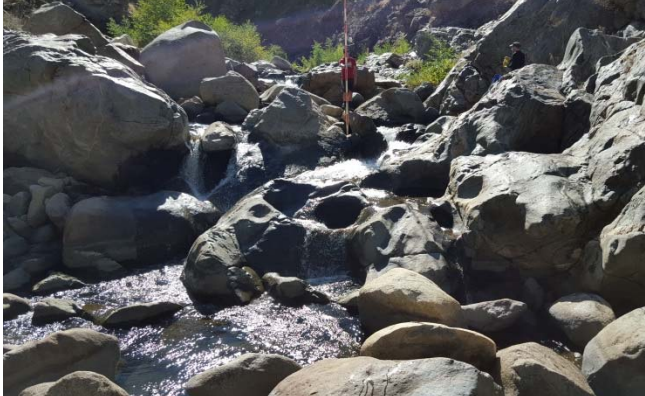
<p>Photo A-46 Waterbody: Cherry Creek Feature: CC-2 River Mile: 0.87 Date: 10/26/2015 Time: 12:30 Image Name: IMG_20151026_123035_-851055533.jpg Coordinates: 37.8947168, - 119.9672991 Total Vertical Height: 8feet Description: Looking upstream at bedrock and boulder step pool falls. Barrier: Potential</p>

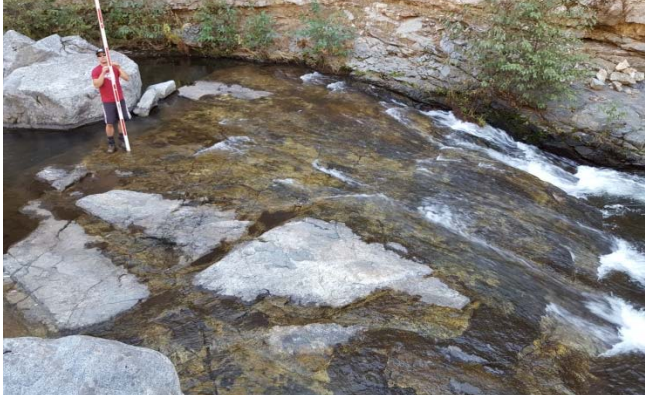
<p>Photo A-47 Waterbody: Cherry Creek Feature: CC-3 River Mile: 1.45 Date: 10/26/2015 Time: 11:18 Image Name: IMG_20151026_111804_-391179401.jpg Coordinates: 37.8945612, -119.9584881 Total Vertical Height: 7feet Description: Overview of bedrock falls from right bank. Barrier: Potential</p>

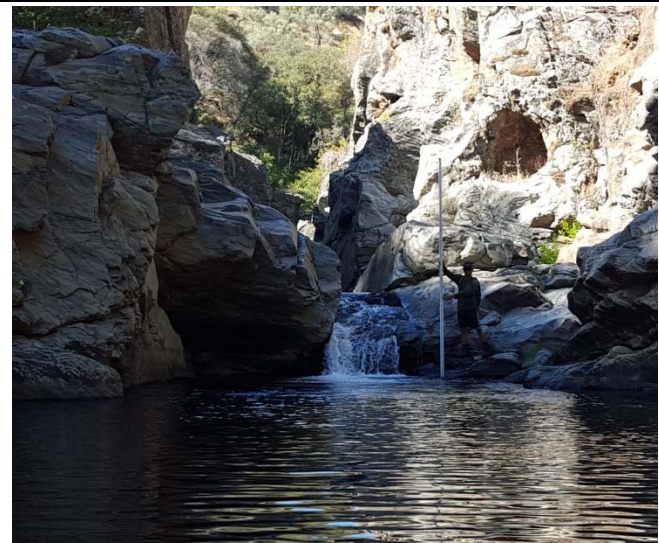
<p>Photo A-51 Waterbody: North Fork Tuolumne River Feature: NT-1 River Mile: 0.52 Date: 7/15/2016 Time: 16:36 Image Name:IMG_20160715_163633_ - 1637339064.jpg Coordinates: 37.9008948, -120.2484138 Total Vertical Height: 5 feet Description: Looking upstream at bedrock chute Barrier: Potential</p>

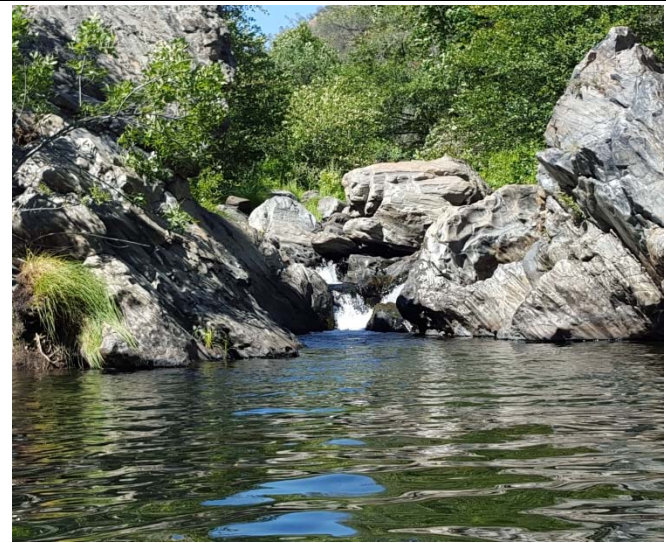
<p>Photo A-55 Waterbody: North Fork Tuolumne River Feature: NT-4 River Mile: 0.72 Date: 7/15/2016 Time: 15:44 Image Name:IMG_20160715_154445_1491411188.jpg Coordinates: 37.9036612, -120.2472935 Total Vertical Height: 6 feet Description: Looking upstream at bedrock falls Barrier: Potential</p>

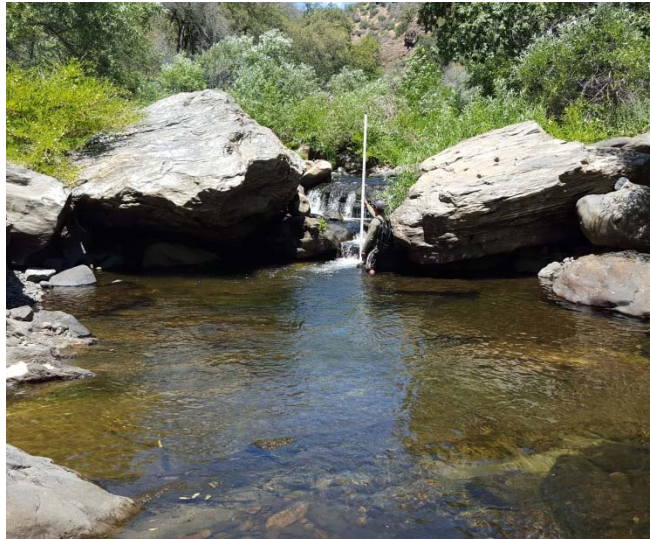
<p>Photo A-57 Waterbody: North Fork Tuolumne River Feature: NT-6 River Mile: 1.54 Date: 7/15/2016 Time: 13:45 Image Name: IMG_20160715_134501_ - 1940720911.jpg Coordinates: 37.9146038, -120.245619 Total Vertical Height: 5 feet Description: Looking upstream at step pool falls Barrier: Potential</p>

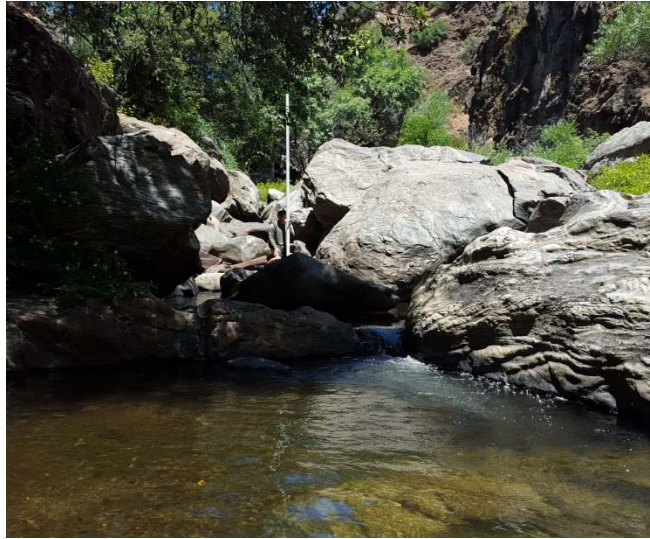
<p>Photo A-58 Waterbody: North Fork Tuolumne River Feature: NT-7 River Mile: 1.60 Date: 7/15/2016 Time: 13:24 Image Name: IMG_20160715_132439_1750772831.jpg Coordinates: 37.9151397, -120.2453156 Total Vertical Height: N/A Description: Looking upstream at downstream extent of boulder field Barrier: Potential</p>

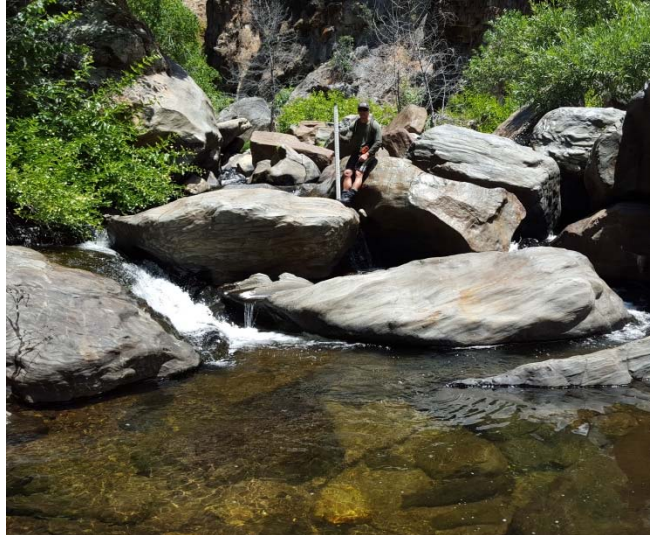
<p>Photo A-59 Waterbody: North Fork Tuolumne River Feature: NT-7 River Mile: 1.60 Date: 7/15/2016 Time: 13:18 Image Name: IMG_20160715_131812_1436285870.jpg Coordinates: 37.9159268, -120.245061 Total Vertical Height: 5ft Description: Looking upstream at leap feature at intermediate pool Barrier: Potential</p>

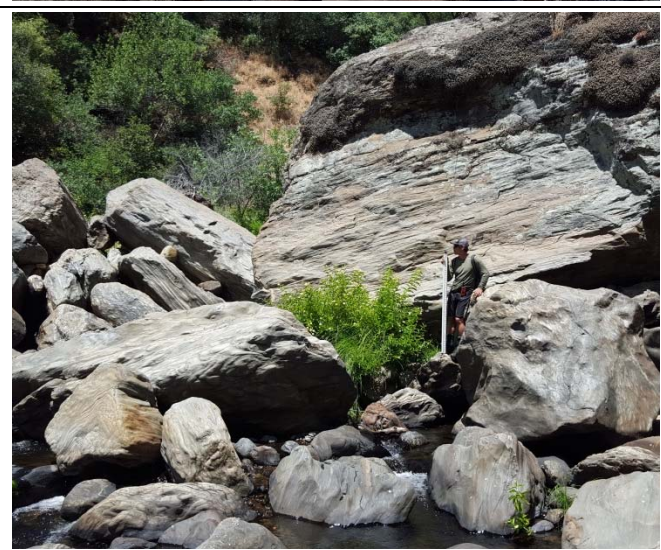
<p>Photo A-61 Waterbody: North Fork Tuolumne River Feature: NT-8 River Mile: 1.65 Date: 7/15/2016 Time: 13:03 Image Name: IMG_20160715_130252_48155320.jpg Coordinates: 37.9161552, -120.2449428 Total Vertical Height: N/A Description: Looking upstream at flow through boulder field Barrier: Passable</p>
