**LA GRANGE HYDROELECTRIC PROJECT  
FERC NO. 14581**

**RECREATION ACCESS AND SAFETY ASSESSMENT STUDY REPORT**

**February 2017**

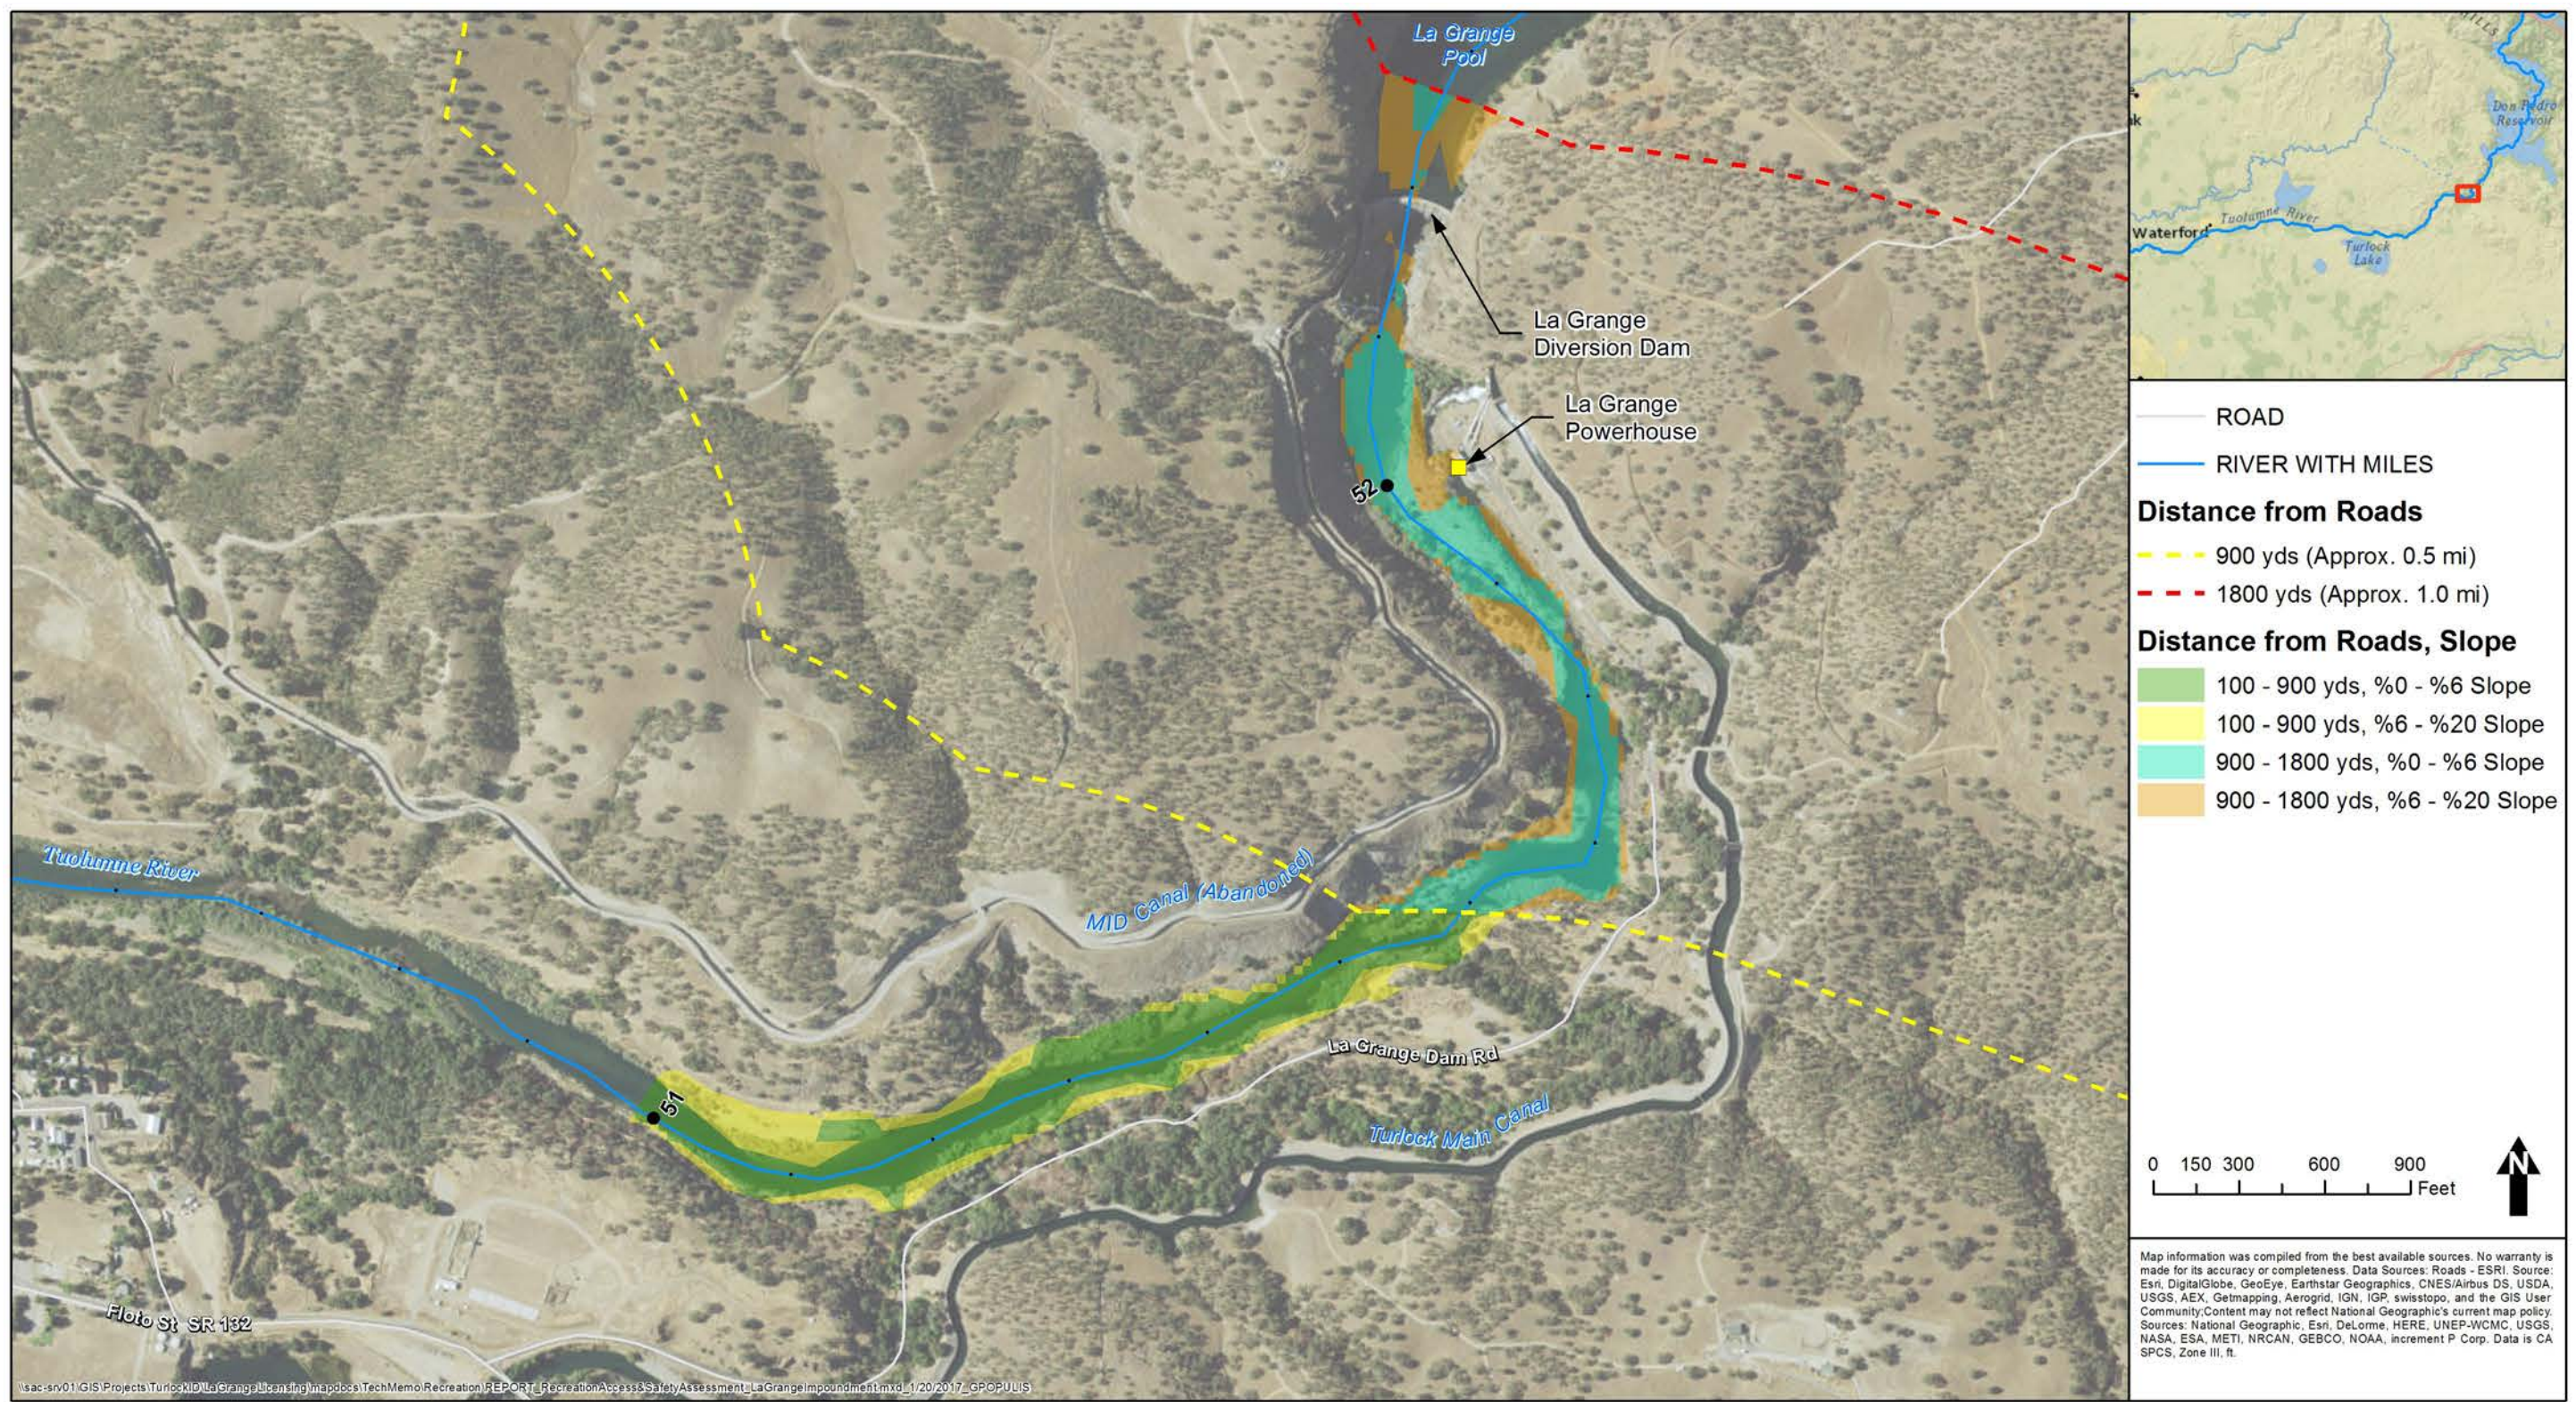
Figure 5.1-3 Analysis of bank slope and distance to Highway 132 for the area downstream of the La Grange Diversion Dam.

Figure 5.1-3 depicts the results of a similar analysis for the area downstream of the La Grange Diversion Dam. Areas downstream of approximately RM 51.6 are within one half-mile from Highway 132, while areas downstream of approximately RM 52.2 are within one mile of Highway 132. An assessment of bank slope up to 20 percent in grade, located within one mile of Highway 132 and within 75 feet of the high water line, indicates that slopes along the riverbank in this reach are generally less steep than slopes along the riverbank upstream of the diversion dam. In particular, significant portions of the shoreline between La Grange Diversion Dam and RM 51.2, especially on river left, lie within approximately one-half mile from Highway 132 and have shoreline slopes of less than six percent. Although river right is within one-half mile of Highway 132, public access from the road to the river is prevented by the MID irrigation canal.

The shoreline on river left between La Grange Diversion Dam at RM 52.2 and RM 51.2 (Figure 5.1-3) is currently accessible by foot and by boat. Public access by vehicle to this reach is prohibited to maintain project security and project safety and to prevent trespassing. TID maintains a locked gate at the top of La Grange Dam Road (a private road maintained by the Districts) to prevent unauthorized vehicles from accessing the powerhouse area and the area immediately downstream of the dam, TID water conveyance structures (intakes and canals), and an employee residence. The powerhouse, water conveyance structures, and residence present significant constraints to providing safe and reasonable public access to this area while maintaining project security.

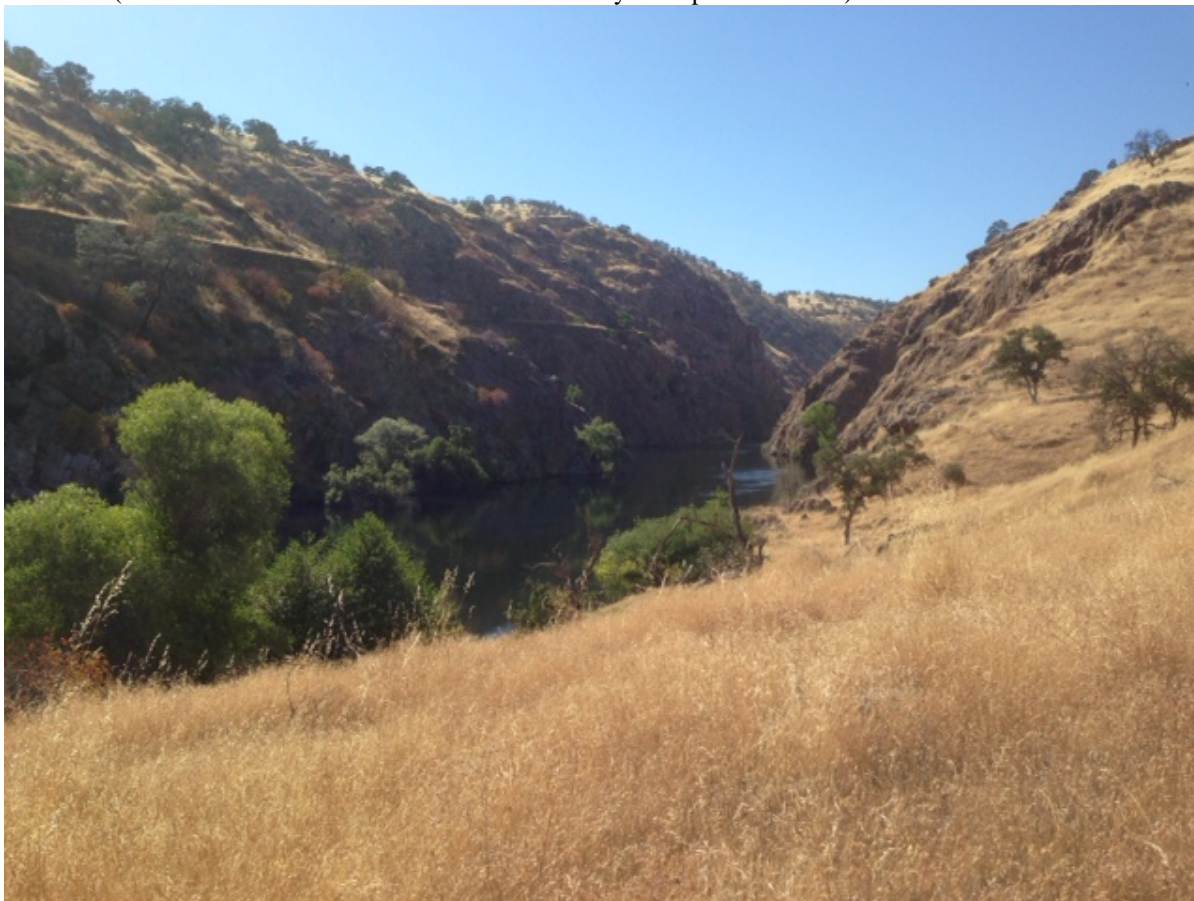
Photo #3 (note rock work - historic canal wall on far canyon slope above river)

Mr. Eicher said the old ditch on the east side of the river, observable from the La Grange Pool Location, is an interesting cultural and historic feature and has potential to serve as a level hiking trail. He said more information is needed on where the ditch begins and ends, as well as the current condition of the ditch. He said if developing the ditch as a trail is not feasible, the ditch still provides an opportunity for cultural interpretation and education.

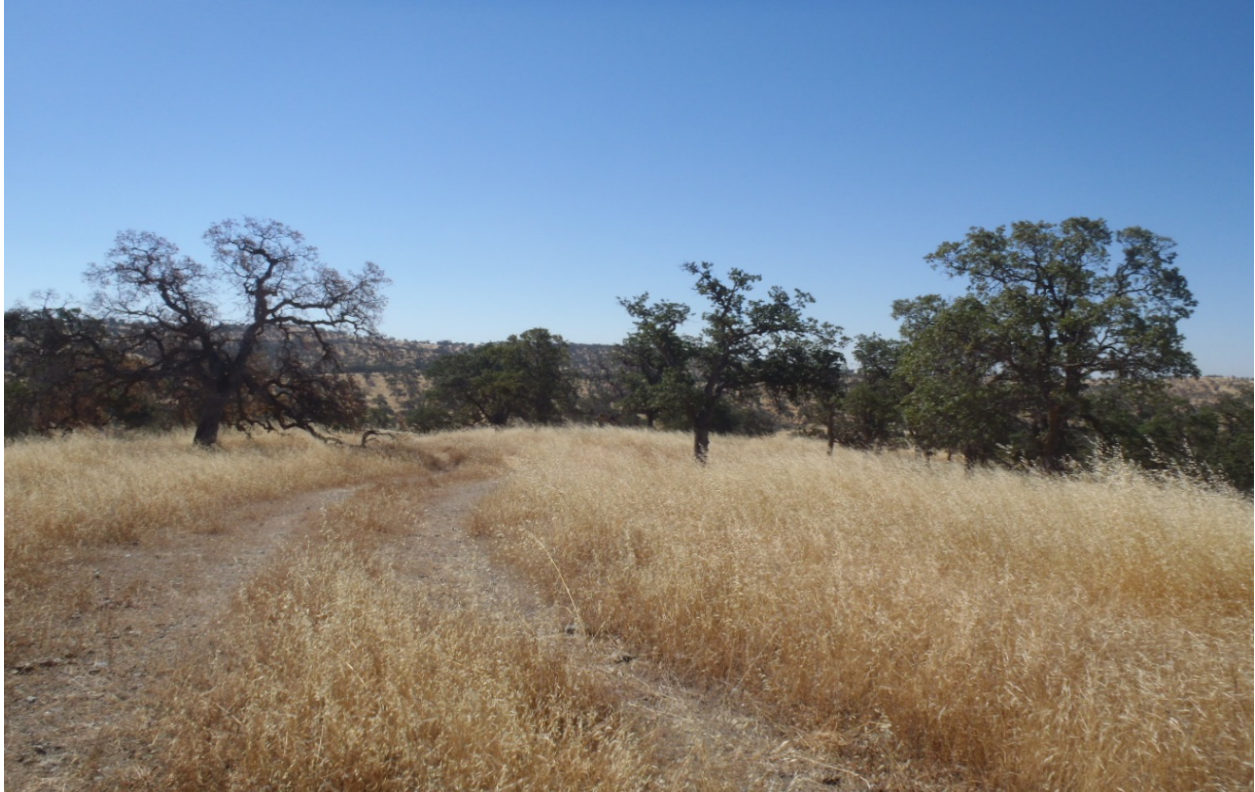
**Photograph C-1. Private unimproved road maintained by the Districts. From here, site visit attendees walked downhill to the shoreline.**

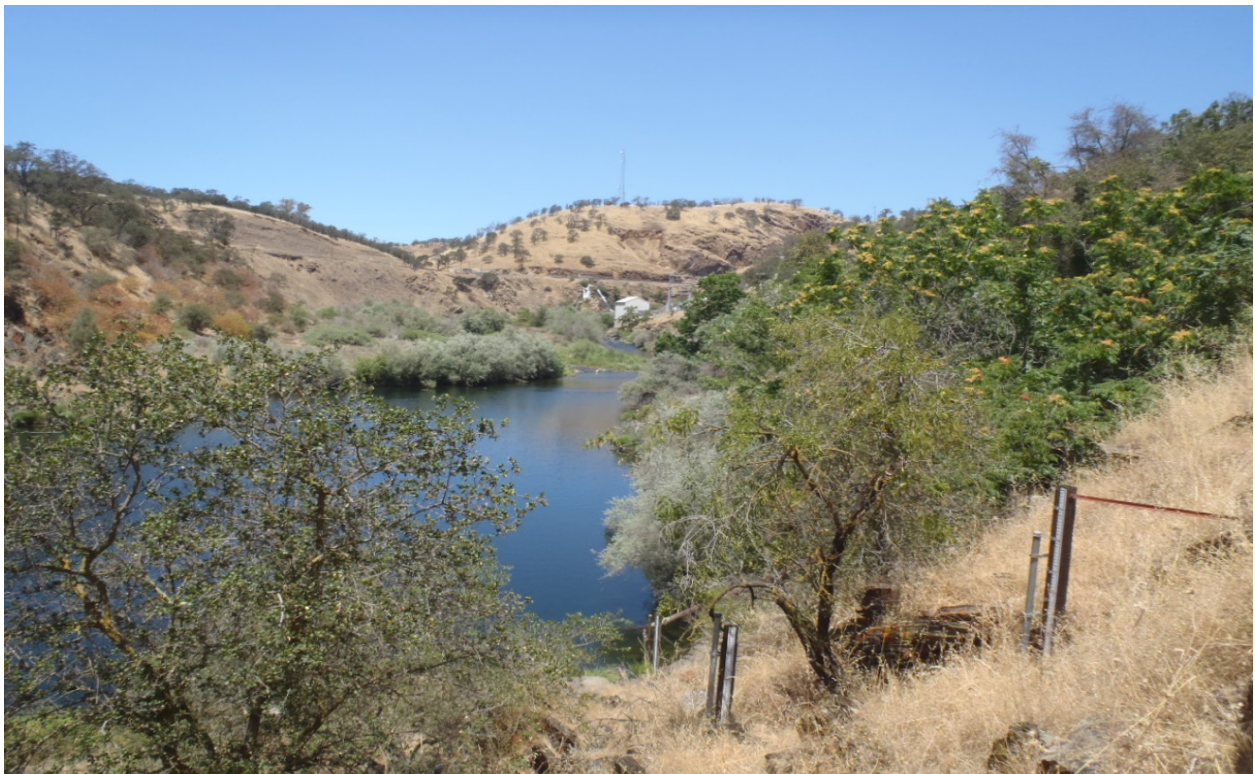
**Photograph D-2. View of the shoreline, looking upstream. The La Grange powerhouse can be seen in the distance.**
